Arkema Facility - Harvey Response

Arkema Inc.

September 6, 2017

Project #109489 Summary

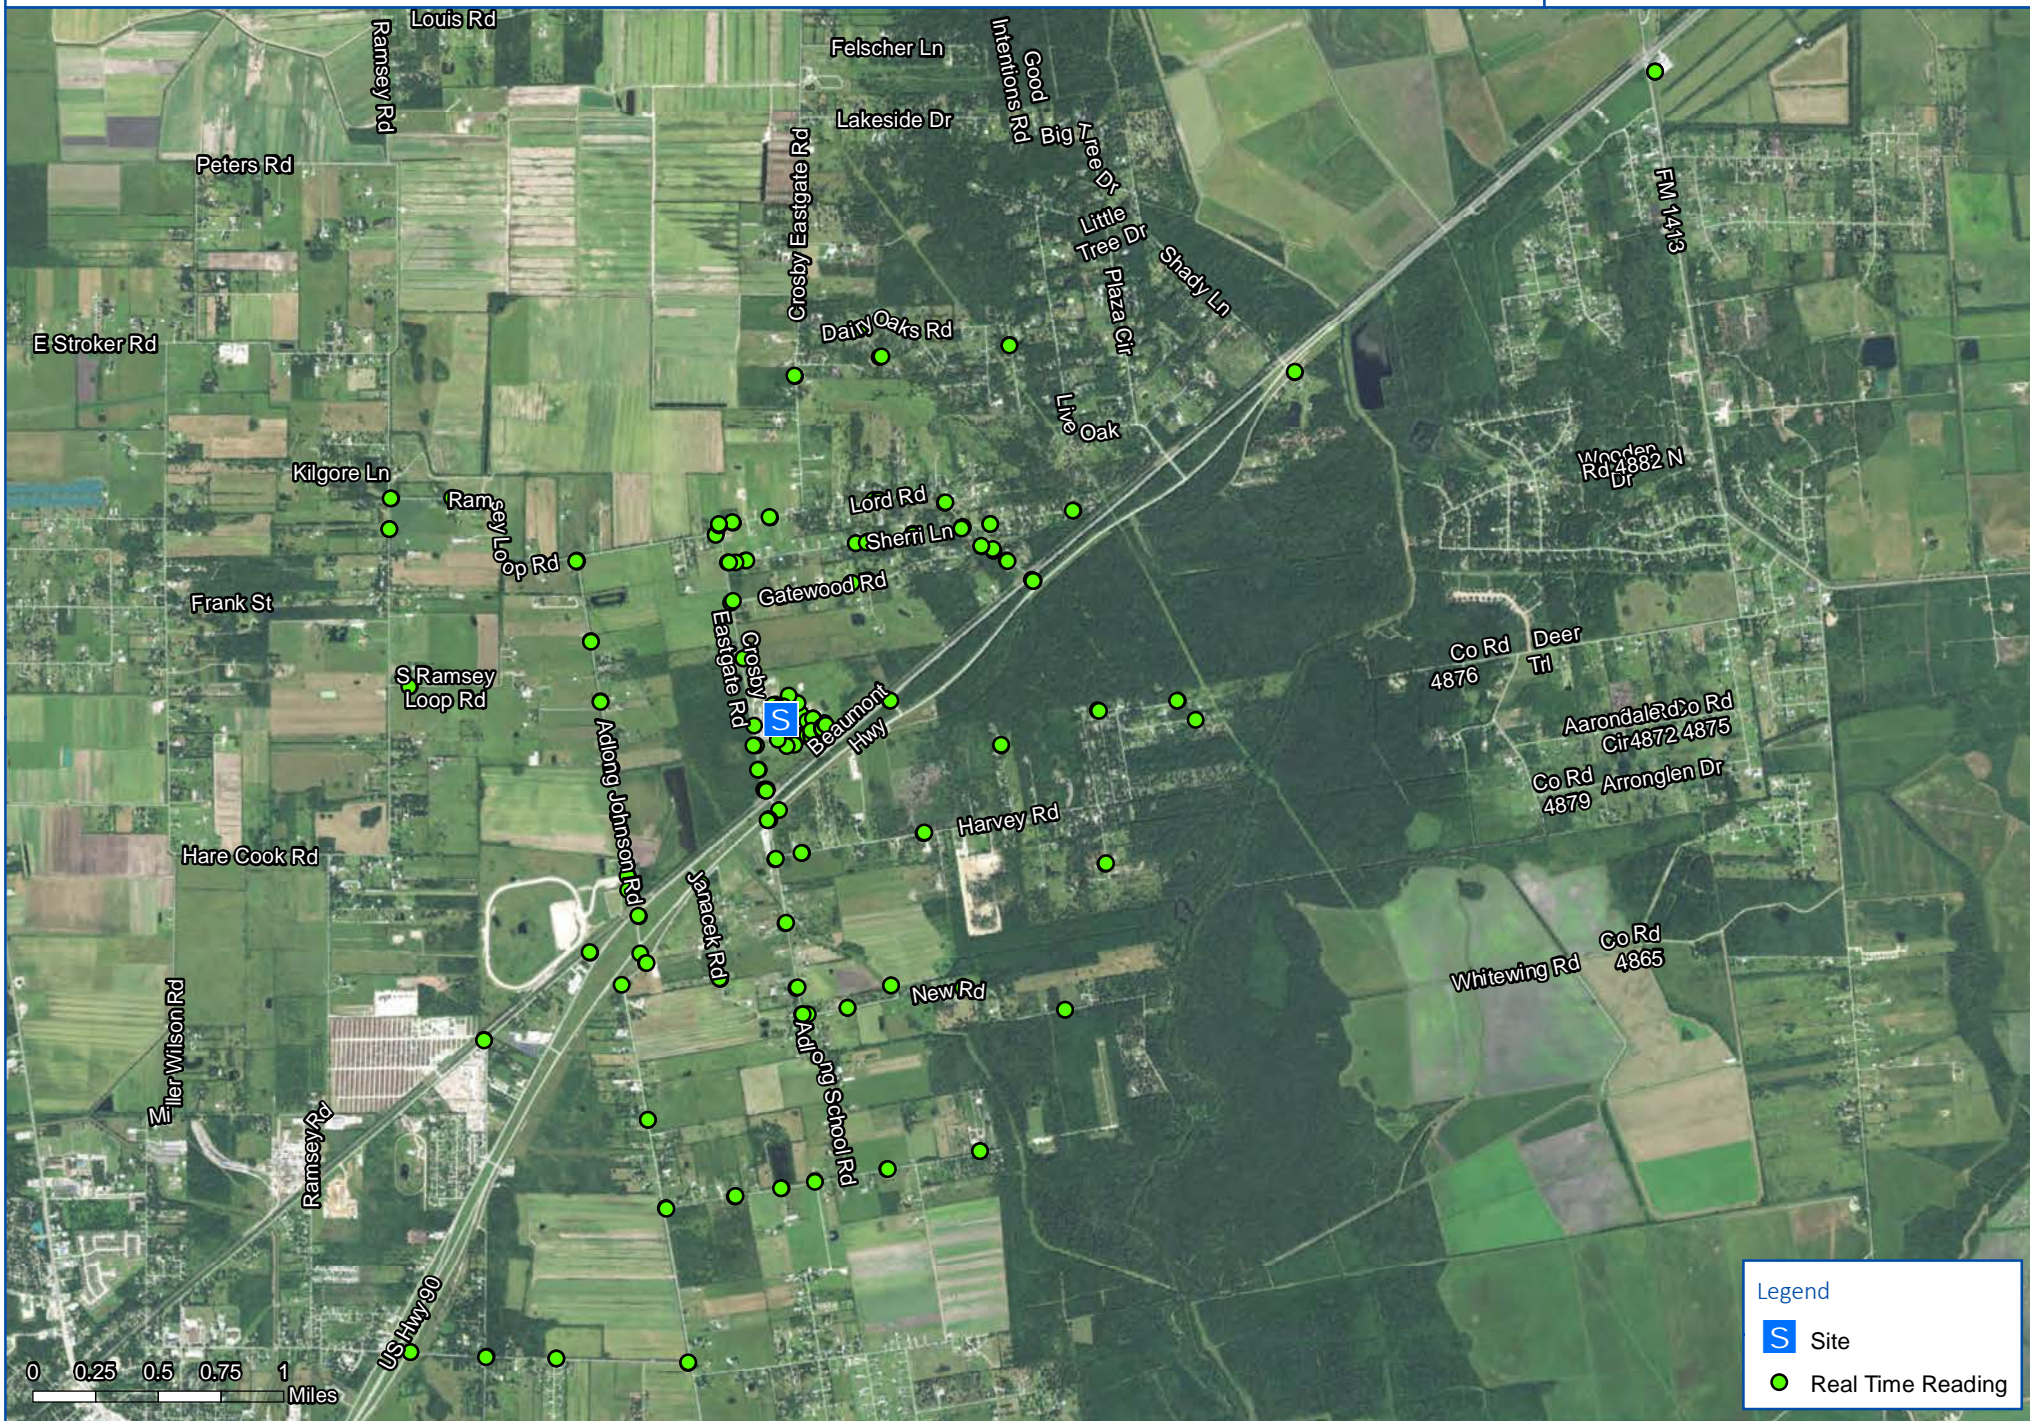
Handheld Real-time Air Monitoring Locations

- Site
- Real Time Reading

All real-time air monitoring instrumentation was calibrated per the manufacturer's recommendations prior to air monitoring. Handheld, real-time air monitoring was conducted for carbon monoxide (CO), lower explosive limit (LEL), oxygen (O₂), and volatile organic compounds (VOCs) using RAE Systems UltraRAE and MultiRAE instruments. Additionally, particulate matter (PM_{2.5}) was assessed using DustTraks, and AM510s. **Table 1** summarizes the data for all real-time air monitoring readings recorded in the Crosby, TX Community from 06:00 on September 5, 2017 through 06:00 on September 6, 2017 and Table 2 summarizes the Worker Activity real-time air monitoring readings from within the site boundary for the same period. Maps of real-time air monitoring locations are provided as **Attachment B**.

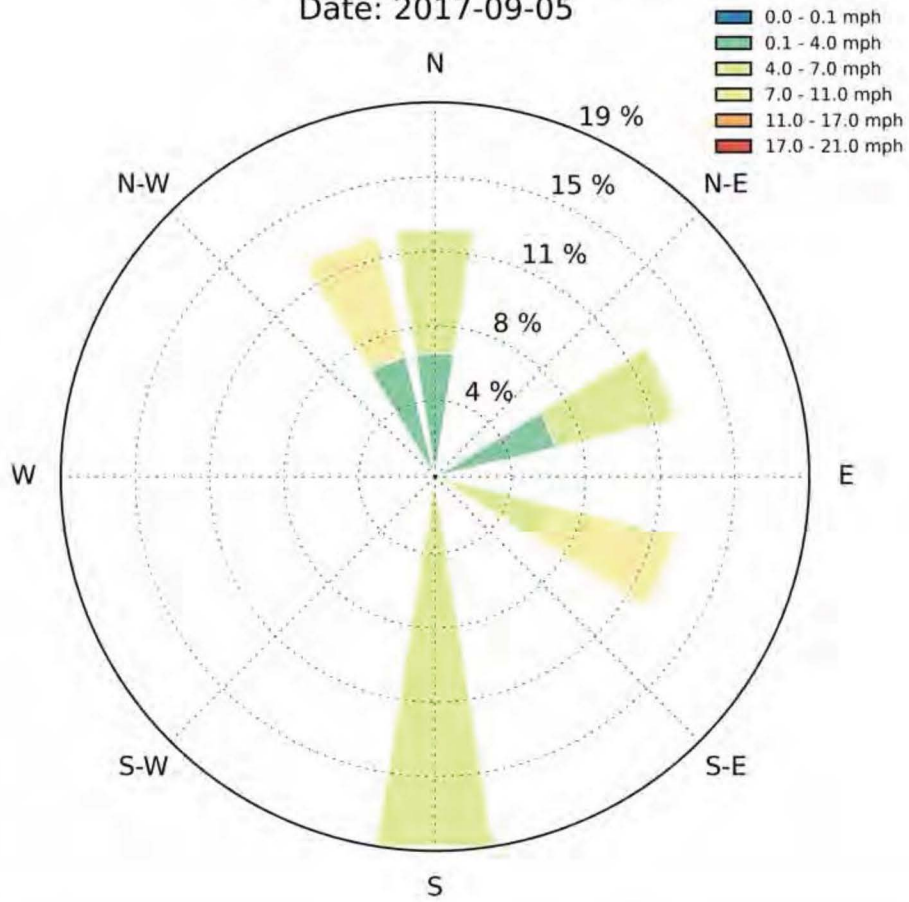
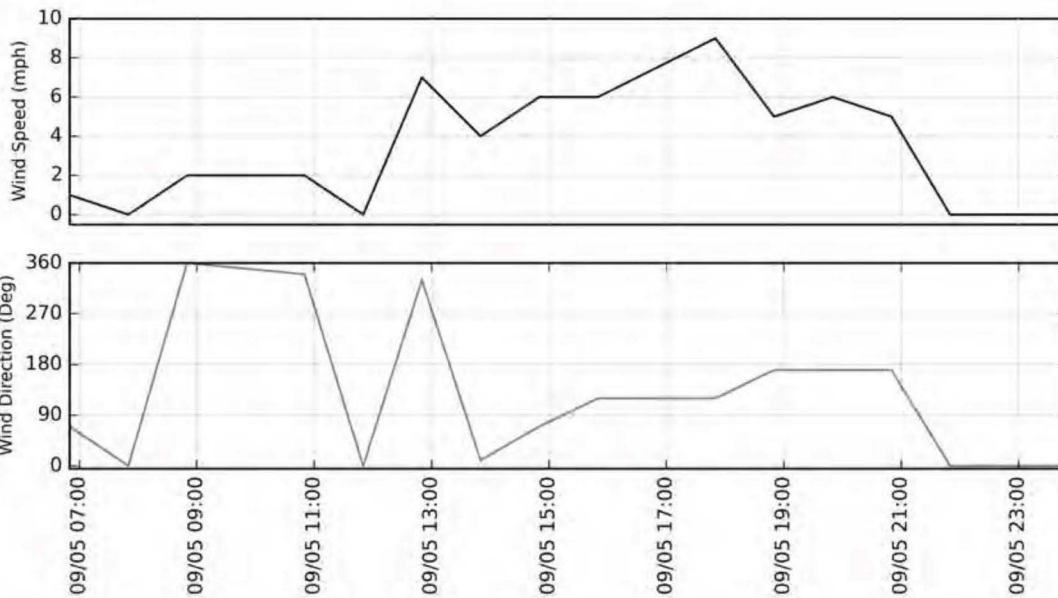
Weather Station: KHPY
Date: 2017-09-05

KHPY Windrose

(Highland Park Airport - 12.5 miles SSE of Site)
